# Special Report 82-6

Cold Regions Research &  
Engineering Laboratory

## *Meteorological conditions causing major ice jam formation and flooding on the Ottawaquechee River, Vermont*

Roy Bates and Mary-Lynn Brown

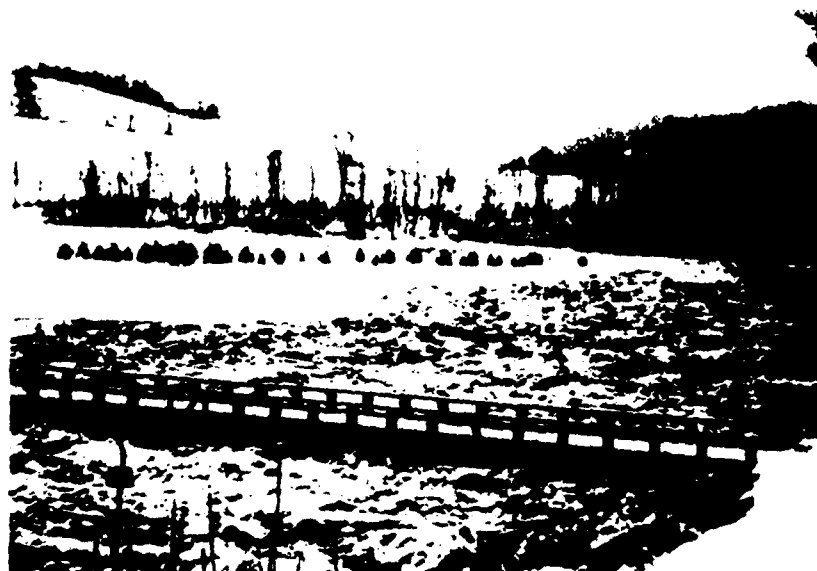
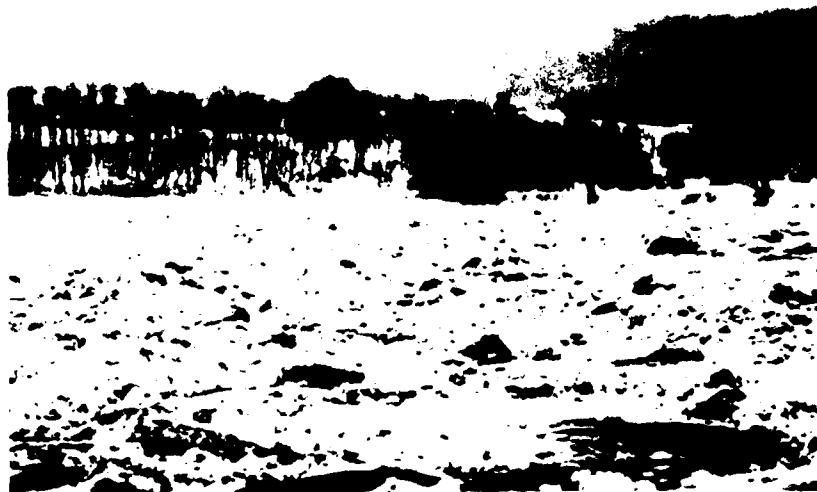
Figure B1. January 1976, Quechee.

During the period 26-28 January 1976 severe ice jamming and flooding was observed on the Ottauquechee River (Fig. B1-B3). Prior to the ice jam of January 1976, greater amounts of ice were observed in the Ottauquechee River than during the same period of the next two winters.

1. Bridges: Elm St. Bridge in Woodstock  
Quechee Lakes Bridge (see Fig. B1)
2. Dams/ponds: Taftsville Pond  
Quechee Mill Pond  
Hartland COE Dam/Pond
3. Near the Woodstock sewage treatment plant (double oxbow)
4. Deep-water pools and low water velocity areas where there is little elevation change (thus facilitating grounding of the ice cover).
5. Shallow areas where the river bends or changes direction.

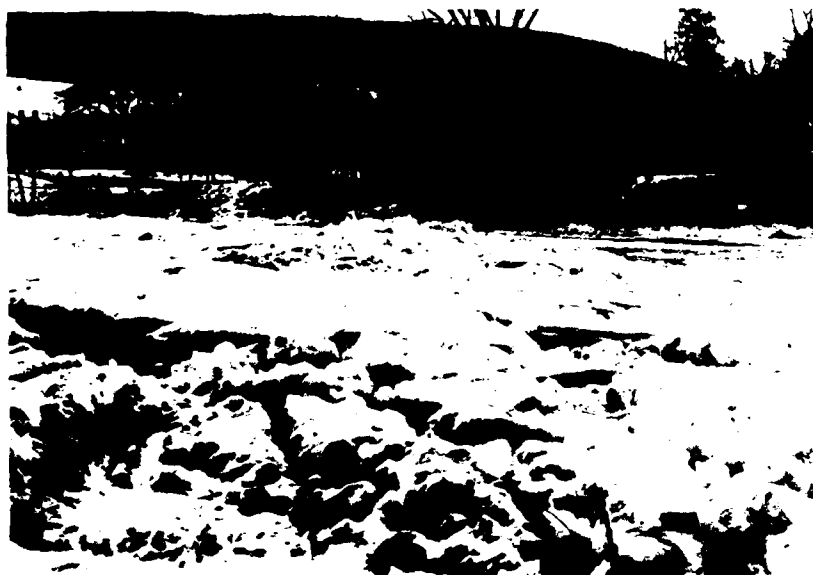
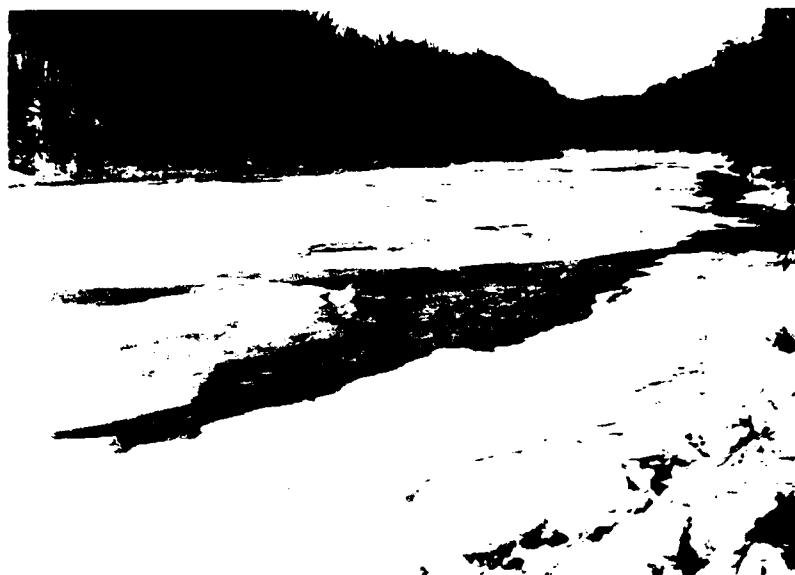
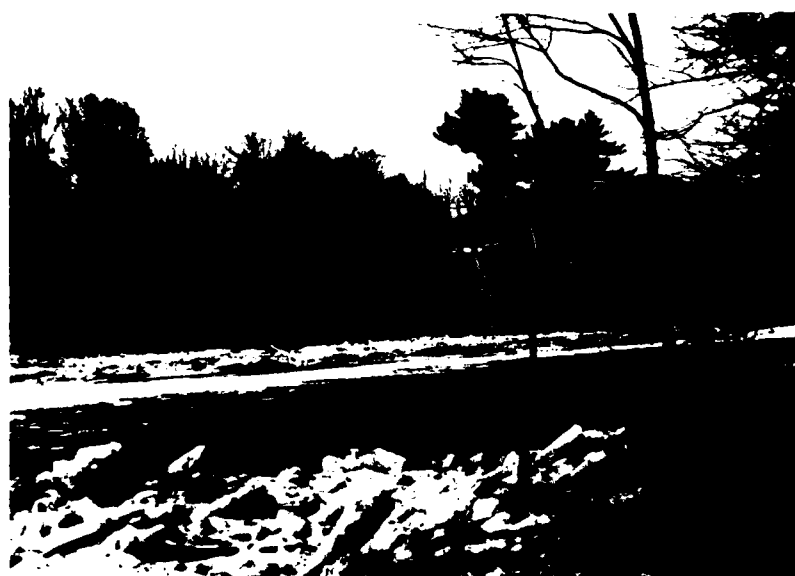
Figure B4. December 1976, Taftsville.

All three winter periods (1975-76, 1976-77, 1977-78) monitored by CRREL personnel along the Ottauquechee River were characterized by the occurrence of ice jams in either December or January. For example two small ice jams unaccompanied by significant rainfall formed during 11-12 December 1976 (Fig. B4-B6) and 4-9 January 78. A third jam formed in late

An ice jam that formed on 11-12 December 1976 and froze in place on the Taftsville and Quechee mill ponds preceded the severe ice jam of 13-14 March 1977 (Fig. B4-B6). This early winter ice jam was caused by warm
